# Preserving Mirror Coating Performance at WIYN

WIYN Technical Report WODC 02-44

David Sawyer (WIYN) and Larry Reddell (NOAO)

September 3, 1997

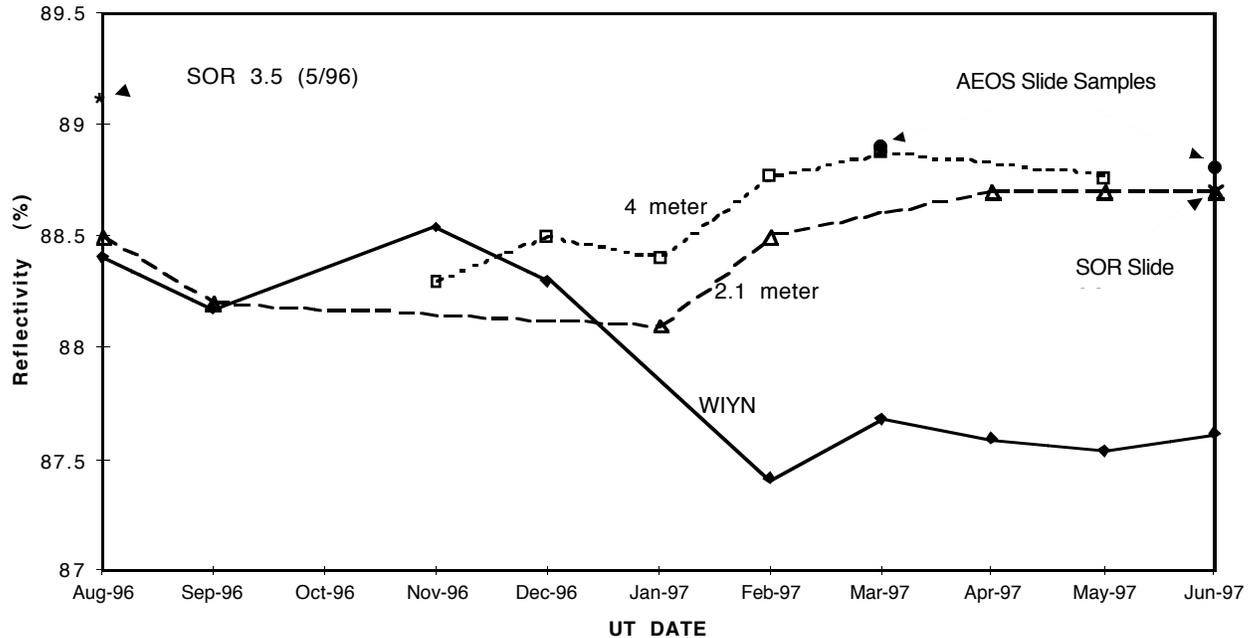
Figure 1 shows the measured reflectance at 670 nm wavelength of the WIYN, the KPNO 2.1 and 4 meter, and the SOR 3.5 meter primary mirrors, along with measurements of the Air Force AEOS and SOR slide samples. The Kitt Peak mirrors were measured with a Minolta CM-2002 and the Air Force mirrors were measured using a TMA  $\mu$ SCAN. A direct comparison of the different reflectometers could not be made because the TMA used by the Air Force was not available. However, the AEOS slide samples were measured in March '97 with the TMA and then in June '97 with the Minolta and the results repeated within 0.1% reflectivity, thus giving an indirect verification of similar instrument calibrations.

**Figure 1:** Reflectivity measurements showing the degradation in WIYN reflectivity as compared to the KPNO 2.1 and 4 meter telescopes and the SOR and AEOS Air Force mirrors.

The reflectivity of the SOR 3.5 mirror was last measured in May '96, but was included in the comparison because the age of the coating is greater than the current WIYN coating. All the mirror coatings, with the exception of WIYN, show similar reflectivities. The reflectivity measurements were made near the inside edges of the mirrors where similar radial distances could be compared. The outer edge of the WIYN mirror has a reflectivity approximately 2% lower than that shown and the degradation in reflectivity at blue wavelengths has been more pronounced at WIYN (see plot in Appendix B), but there is no comparative data available for the SOR mirror because of limitations of the TMA  $\mu$ SCAN reflectometer.

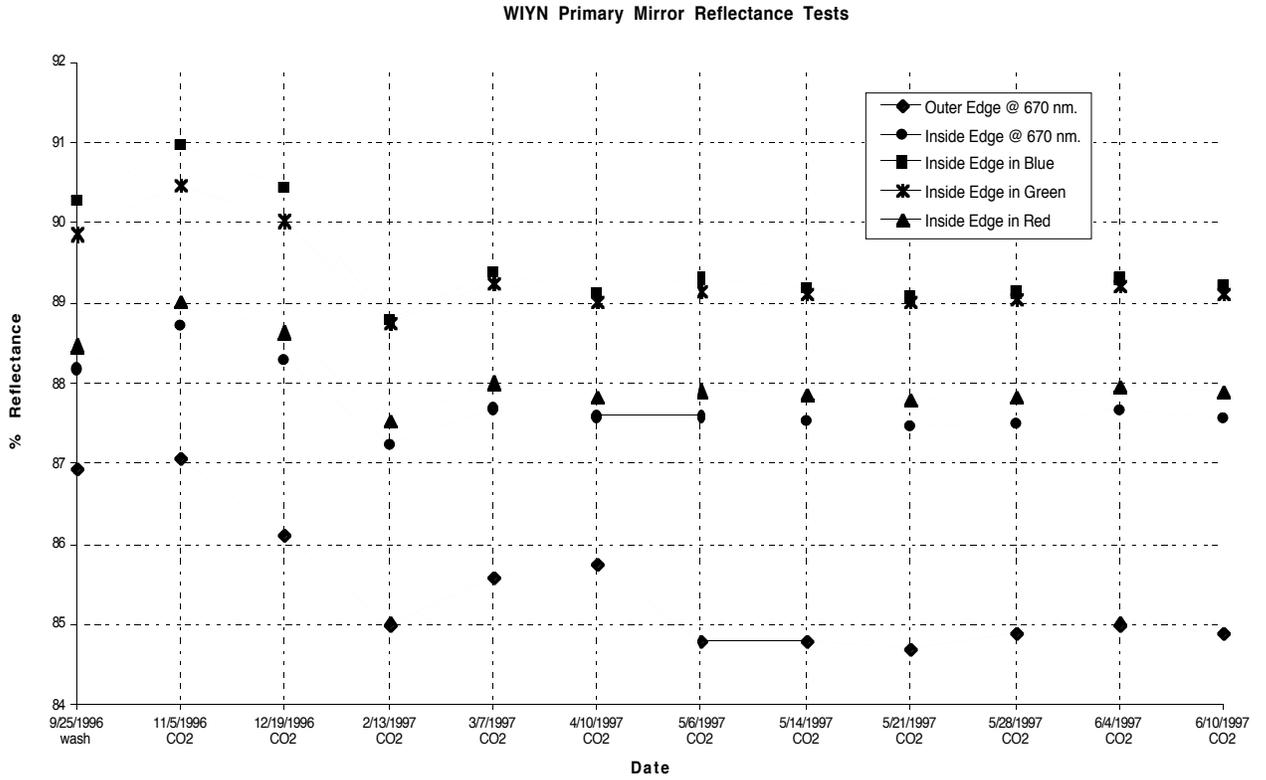
**Figure B1:** Reflectivity performance of the WIYN primary mirror as a function of wavelength and radial position.
